# CRUISE<sup>TM</sup> MASTER

# BCS

## BODY CONTROL SYSTEM

## Diagnostic Manual

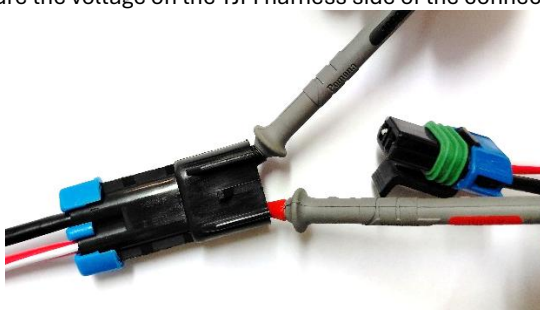
| Step | Action | If Yes | If No |
|---|---|---|---|
| 21 | Reconnect the power supply to the TJM harness (F-37749).<br>Disconnect the connector between the TJM harness (F-37749) and the Compressor (red/white and black cables).<br>Use Home>Manual mode to activate the Compressor output.<br>Measure the voltage on the TJM harness side of the connection.<br><br>Is Battery voltage present? | Go to Step 22 | Go to Step 23 or 24 |
