CRUISETM MASTER

BCS

BODY CONTROL SYSTEM

Diagnostic Manual

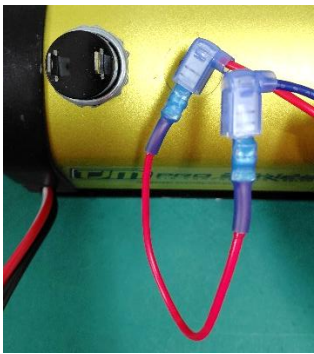
Step	Action	If Yes	If No
1	Activate the Tank Drain function (Tools menu>Air Tank Drain) until air can no longer be heard venting. Use Home>Manual mode to activate the Compressor output. Does the compressor run?	System OK.	Go to Step 2
2	If a switch has been installed to isolate the compressor, is it set correctly? Are all cables and connectors between the BCM and the Compressor Harness firmly connected, undamaged and installed in accordance with the Installation Manual?	Go to Step 4	Go to Step 3
3	Rectify any issues found in Step 2 then return to Step 1.		
4	Activate the Tank Drain function (Tools menu>Air Tank Drain) until air can no longer be heard venting. Run a Solenoid Test (Tools menu>Solenoid Test). Check the result for AIR COMP , is the value less than 0.05?	Go to Step 5 or 6	Go to Step 17
5	Disconnect the cable connectors from the Pressure Switch. Use Home>Manual mode to activate the Compressor output. Briefly bridge the cable connectors on the TJM Harness side.

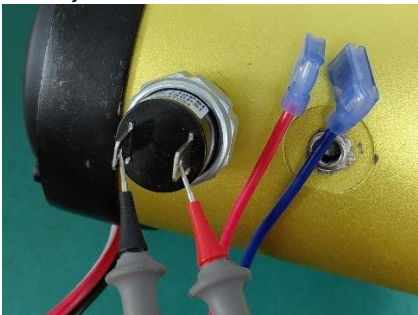
6	Disconnect the cable connectors from the Pressure Switch. Check for continuity between the Pressure Switch terminals.

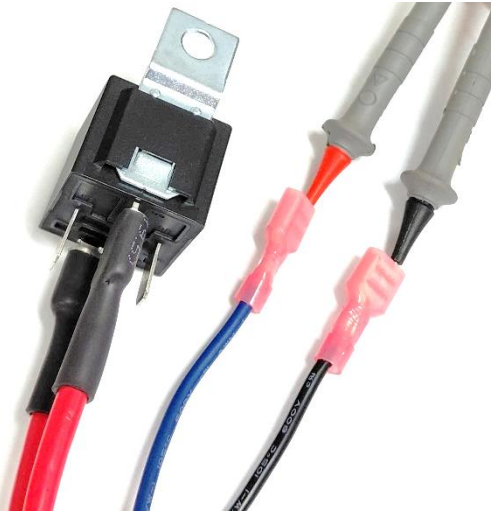
Is resistance greater than 240 ohm?	Go to Step 10	Go to Step 11
10	Replace Relay		
11	Use Home>Manual mode to activate the Compressor output. Measure the voltage between the relay connector pins that correspond with relay pins marked 85 and 86 in the diagram below.

Step	Action	If Yes	If No
9	Reconnect the cables to the Pressure Switch. Disconnect the connectors for pins marked 85 and 86 in the diagram below from the relay. Measure the resistance across the relay pins marked 85 and 86.

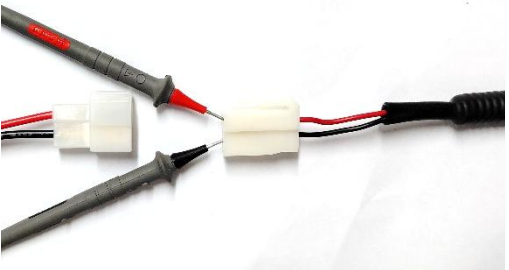
Is the voltage greater than 10V?	Contact Cruisemaster Technical Support.	Go to Step 12
12	Disconnect the Compressor/Tank Drain cable (32C-060) from the TJM supplied compressor harness (F-37749). Use Home>Manual mode to activate the Compressor output. Measure the voltage across the connector pins shown.

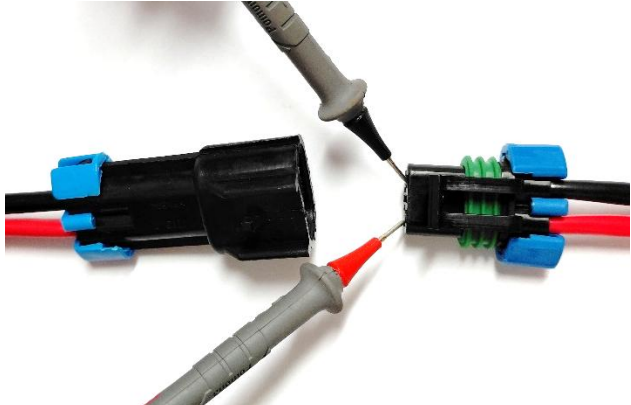
Step	Action	If Yes	If No
15	Replace the Compressor/Tank Drain cable (32C-060).		
16	Replace BCM (Contact Cruisemaster Technical Support for confirmation)		
17	Check the Compressor fuse (40A) Is the fuse intact?	Go to Step 19	Go to Step 18
18	Replace fuse. Use Home>Manual mode to activate the Compressor output. Does the compressor run? If the fuse blows again, contact Cruisemaster Technical Support.	System OK	Go to Step 19
19	Disconnect the power supply (red and black cables) from the TJM harness (F-37749) Measure the voltage between the pins on the power supply side.

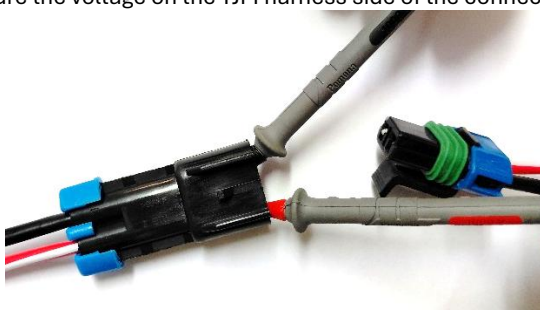
Is Battery voltage present?	Go to Step 21	Go to Step 20
20	Rectify wiring upstream to the battery.		
21	Reconnect the power supply to the TJM harness (F-37749). Disconnect the connector between the TJM harness (F-37749) and the Compressor (red/white and black cables). Use Home>Manual mode to activate the Compressor output. Measure the voltage on the TJM harness side of the connection.

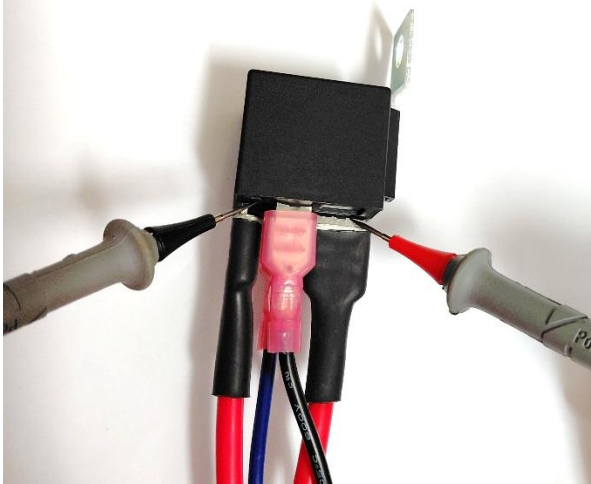
Step	Action	If Yes	If No
24	<p>Use Home>Manual mode to activate the Compressor output. Check for continuity between pins 87 and 30 on the relay connector.</p>

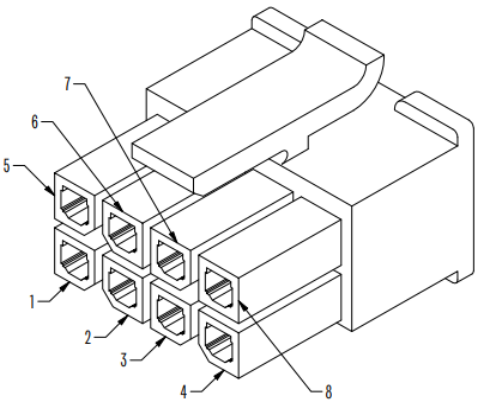
Step	Action	If Yes	If No
1	Clear the Fault Report, does the Fault remain?	Go to Step 2	System OK
2	Disconnect LEFT ACM, RIGHT ACM and INFLATOR cables from the BCM, is the 5V REG value between 4.85V and 5.15V?	Go to Step 5	Go to Step 3
3	<p>Disconnect the ACMs from each ACM and INFLATOR cable. On the ACM Cable side of the connection to the BCM:</p> <ul style="list-style-type: none"> • Ensure the connector terminals are fully seated in the correct positions and undamaged. • Check for continuity between: <ul style="list-style-type: none"> ○ Pin 5 and Pin 7 ○ Pin 6 and Pin 7

<p style="text-align: center;"><i>ACM Cable BCM Connector</i></p> <p>At each ACM:</p> <ul style="list-style-type: none"> • Check for continuity between: <ul style="list-style-type: none"> ○ Pin 1 and Pin 6 ○ Pin 1 and Pin 8

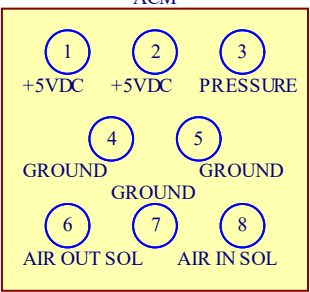
<p style="text-align: center;"><i>ACM Connector with air connections pointing upward</i></p> <p>Is continuity present on any of the ACM cables or ACMs?</p>	Go to Step 4	Contact Cruisemaster Technical Support.

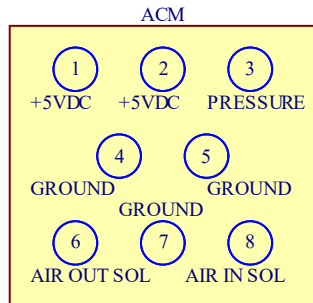
Step	Action	If Yes	If No
1	Is H06 or SV05 fault also reported?	Go to Step 2	Go to Step 3
2	Rectify H06 or SV05 fault first.		
3	Check the measured value POS , is the value between 0.5 and 4.5?	Go to Step 4	Go to Step 5
4	Note the fault for future reference. Is the fault recurrent?	Contact CruiseMaster Technical Support.	System OK
5	Are all cables and connectors between the BCM, left ACM and left Position Sensor firmly connected, undamaged and installed in accordance with the Installation Manual?	Go to Step 7 or 8	Go to Step 6
6	Rectify any issues found in Step 5. Clear the Fault Report. Does the fault remain?	Go to Step 7 or 8	System OK
7	Temporarily replace the left ACM with a known good ACM. Clear the Fault Report. Does the fault remain?	Go to Step 10	Go to Step 9
8	Disconnect the ACM cable from the ACM. On the ACM side, check for electrical continuity between pins 1 and 2, and between pins 4 and 5. Reconnect the ACM cable to the ACM. Is continuity present in both checks? <div data-bbox="405 1243 718 1545" data-label="Diagram">

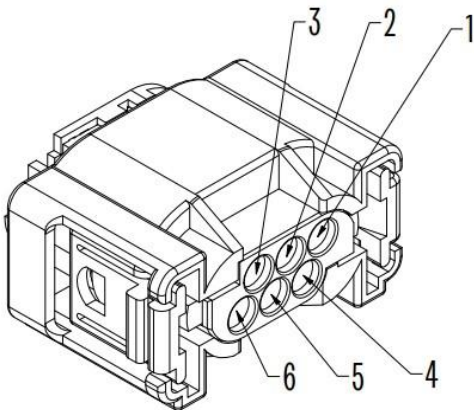
<p><i>ACM Cable Position Sensor Connector</i></p>	Go to Step 14	Go to Step 15

Step	Action	If Yes	If No
13	<p>Disconnect the Position Sensor from the ACM Cable.</p> <p>On the ACM Cable side:</p> <ul style="list-style-type: none"> Check the voltage at the position sensor connector between pin 1 (negative) and pin 5 (positive) is between 4.5V and 5.5V Ensure the connector terminals are fully seated in the correct positions and undamaged. <p>Are both conditions above met?</p>

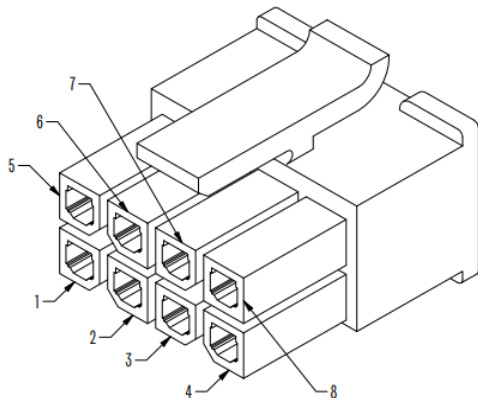
Step	Action	If Yes	If No
14	<p>Disconnect the BCM and Position Sensor from the ACM Cable. On the ACM Cable side:</p> <ul style="list-style-type: none"> • Ensure the connector terminals are fully seated in the correct positions and undamaged. • Check that continuity exists between <ol style="list-style-type: none"> 1. BCM connector pin 4 (Position Sensor signal)

<p style="text-align: center;"><i>ACM Cable BCM Connector</i></p> <ol style="list-style-type: none"> 2. Position Sensor connector pin 4 (Position Sensor signal)

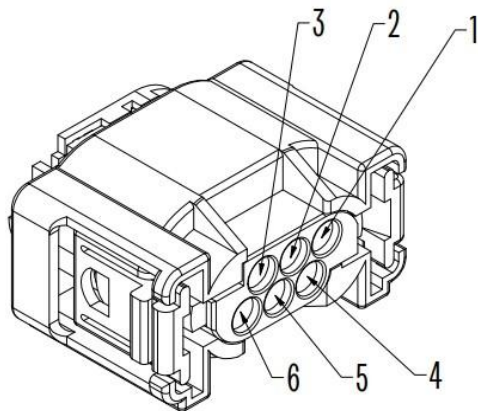
<p style="text-align: center;"><i>ACM Cable Position Sensor Connector</i></p> <p>Are both conditions above met?</p>	Contact Cruisemaster Technical Support.	Go to Step 15
15	Replace ACM Cable

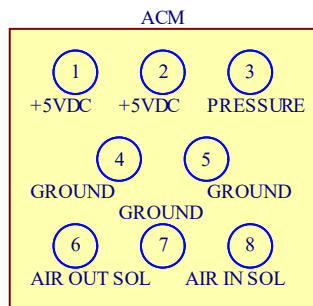
Step	Action	If Yes	If No
1	Is H06 or SV05 fault also reported?	Go to Step 2	Go to Step 3
2	Rectify H06 or SV05 fault first.		
3	Check the measured value POS , is the value between 0.5 and 4.5?	Go to Step 4	Go to Step 5
4	Note the fault for future reference. Is the fault recurrent?	Contact CruiseMaster Technical Support.	System OK
5	Are all cables and connectors between the BCM, right ACM and right Position Sensor firmly connected, undamaged and installed in accordance with the Installation Manual?	Go to Step 7 or 8	Go to Step 6
6	Rectify any issues found in Step 5. Clear the Fault Report. Does the fault remain?	Go to Step 7 or 8	System OK
7	Temporarily replace the right ACM with a known good ACM. Clear the Fault Report. Does the fault remain?	Go to Step 10	Go to Step 9
8	Disconnect the ACM cable from the ACM. On the ACM side, check for electrical continuity between pins 1 and 2, and between pins 4 and 5. Reconnect the ACM cable to the ACM. Is continuity present in both checks? <div data-bbox="405 1240 718 1545" data-label="Diagram">

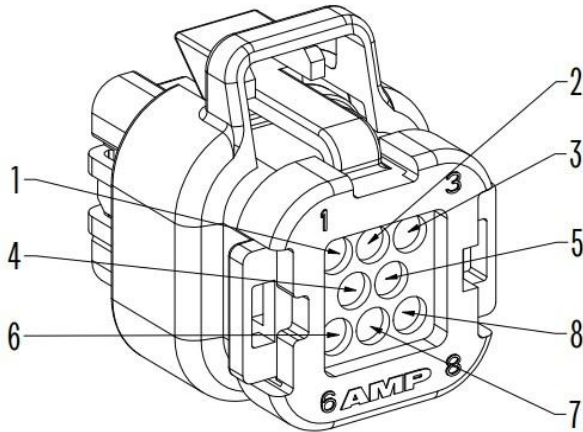
ACM Cable ACM Connector

10	Disconnect the ACM from the ACM Cable. On the ACM Cable side: <ul style="list-style-type: none"> • Check the voltage at the ACM connector between pin 1 (positive) and pin 4 (negative) is between 4.5V and 5.5V • Ensure the connector terminals are fully seated in the correct positions and undamaged. Are both conditions above met? <div data-bbox="268 1429 853 1859">

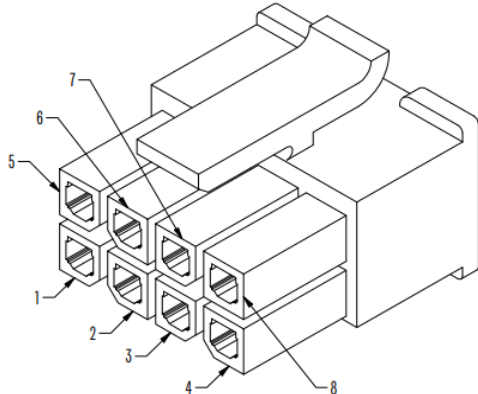
Step	Action	If Yes	If No
11	<p>Disconnect the BCM and ACM from the ACM Cable. On the ACM Cable side:</p> <ul style="list-style-type: none"> Ensure the connector terminals are fully seated in the correct positions and undamaged. Check that continuity exists between <ol style="list-style-type: none"> 5. BCM connector pin 8 (Pressure signal)

<p style="text-align: center;"><i>ACM Cable BCM Connector</i></p> <ol style="list-style-type: none"> 6. ACM connector pin 3 (Pressure signal)

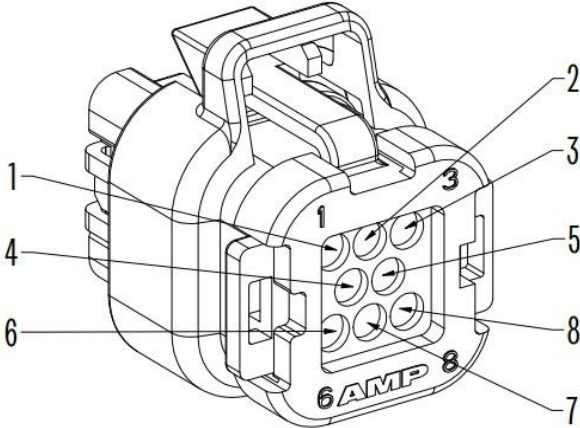
<p style="text-align: center;"><i>ACM Cable ACM Connector</i></p> <p>Are both conditions above met?</p>	Contact Cruisemaster Technical Support.	Go to Step 12
12	Replace ACM Cable

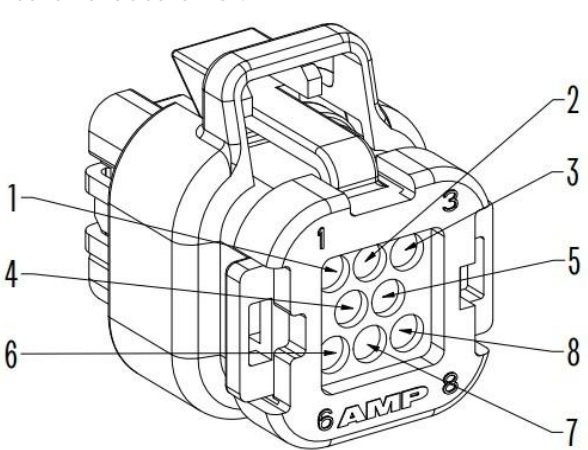
ACM Cable ACM Connector

10	Disconnect the ACM from the ACM Cable. On the ACM Cable side: <ul style="list-style-type: none"> • Check the voltage at the ACM connector between pin 1 (positive) and pin 4 (negative) is between 4.5V and 5.5V • Ensure the connector terminals are fully seated in the correct positions and undamaged. Are both conditions above met?

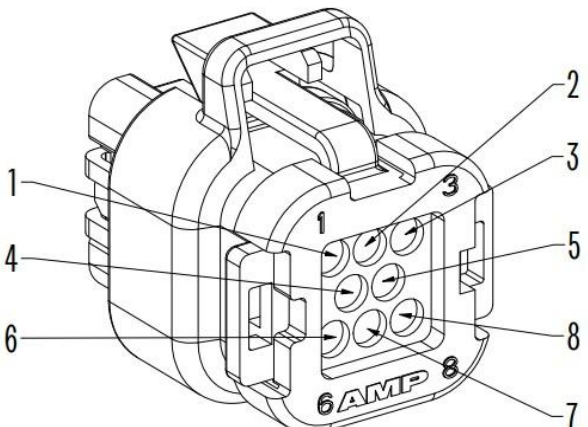
10	<p>Disconnect the Inflator ACM from the Inflator ACM Cable.</p> <p>On the Inflator ACM Cable side:</p> <ul style="list-style-type: none"> • Check the voltage at the Inflator ACM connector between pin 1 (positive) and pin 4 (negative) is between 4.5V and 5.5V • Ensure the connector terminals are fully seated in the correct positions and undamaged. <p>Are both conditions above met?</p>

<p style="text-align: center;"><i>Inflator ACM Cable ACM Connector</i></p>	Go to Step 11	Go to Step 12
