CUSTOMER INFORMATION SHEET – NO. 23

PROLONGING TYRE LIFE

Prolonging Tyre Life on Trailers and Caravans...It's Not Just a Case of Poor Alignment!

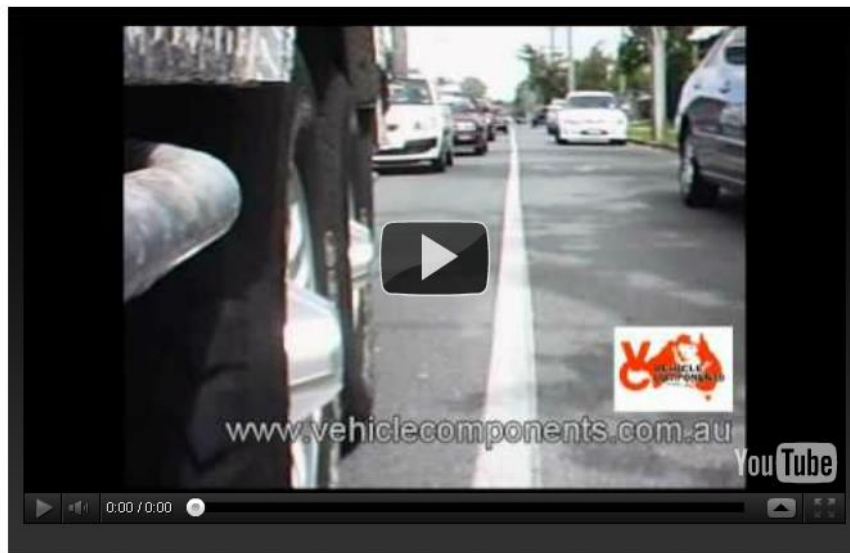
On tandem applications the close proximity of the two axles does not allow all tyres to freely rotate when cornering. This means that some or all of the tyres will be trying to scrub sideways every time the van turns a corner.

Sideways scrubbing can lead to increased wear as well as uneven wear across the tyre as the tyre tries to tuck under. This may look similar to camber wear as the tyre becomes worn on one edge.
